## THE MOSAIC PAVEMENT SUBSTRATES IN THE SOUTHERN ROOMS OF THE EASTERN CHURCH AT KHIRBET ET-TIREH, RAMALLAH (PALESTINE)

Salah Hussein AL-HOUDALIEH\* and Hamdallah BEARAT\*\*

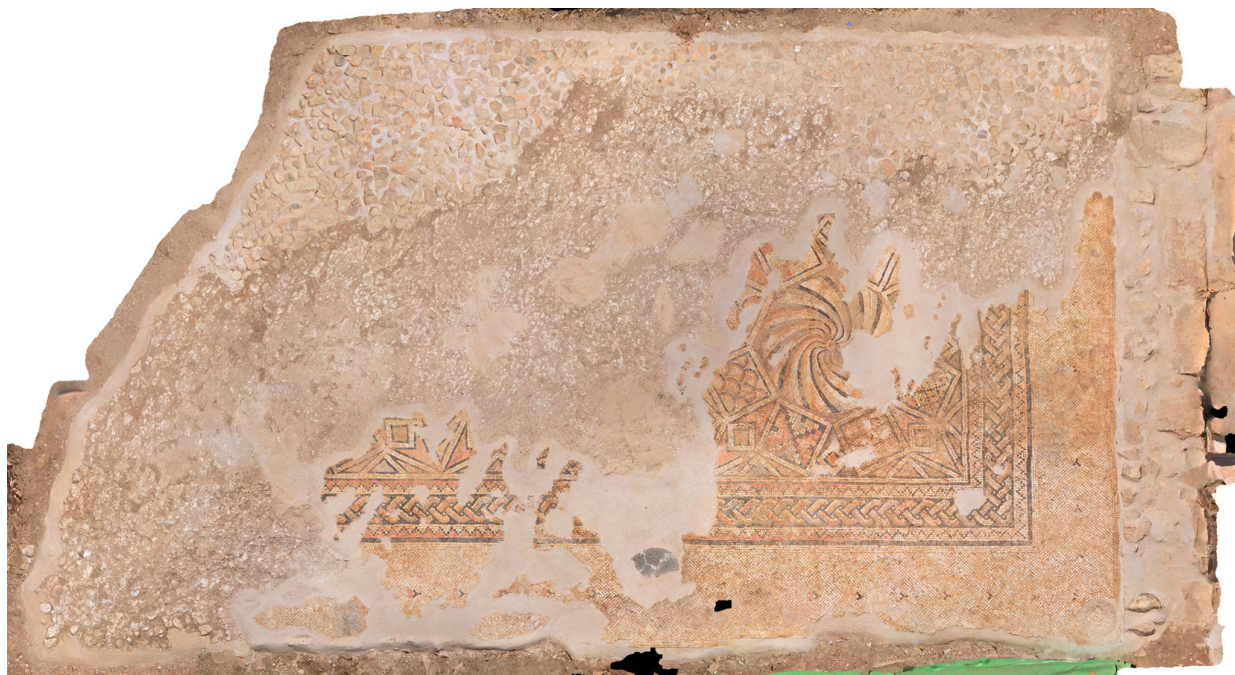
FIG. 4. *The mosaic and repair of the floor pavement of Room 4 (photo by N. Fetyani).*

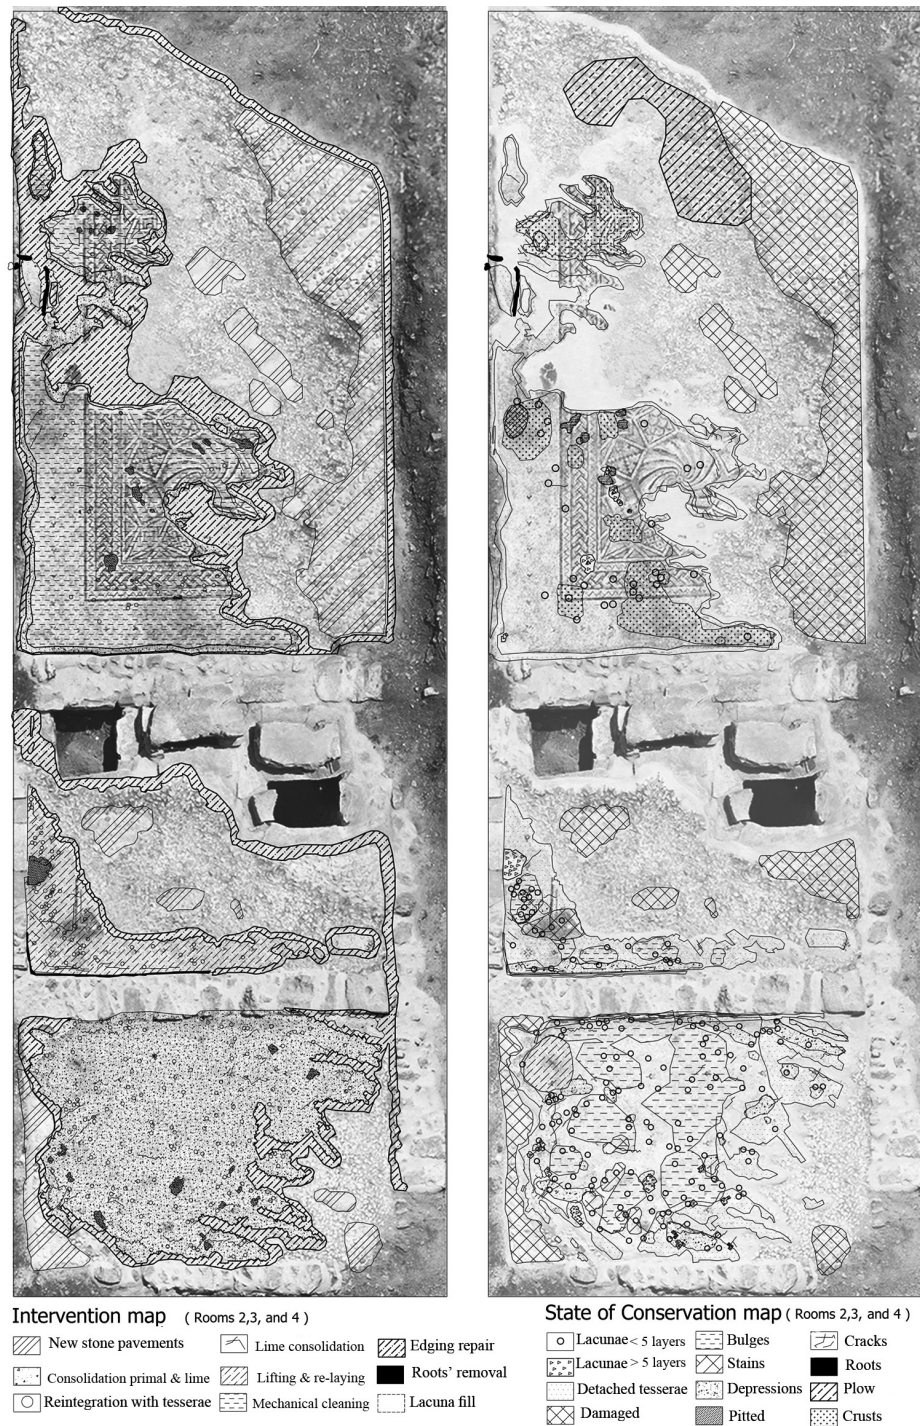
FIG. 5. *Condition assessment and intervention map (prepared by R. Khalil).*

2) Documenting the physical condition of the mosaic pavements through visual inspection and textual recording; preparing a series of thematic charts detailing the physical condition of the surveyed pavements, especially noting all visible problems (Fig. 5); compiling a written description of the problems relating to these floors; and finally, formulating a detailed action plan for intervention.

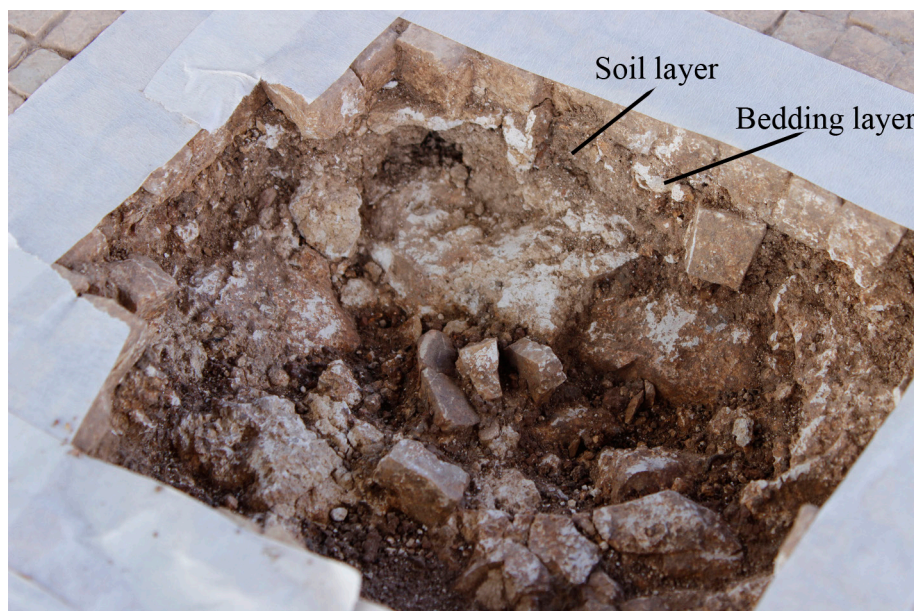
FIG. 7. The soil layer in between the bedding layer and nucleus in Room 2.

lacunae or cracks–, and the results of this work revealed the same soil layer seen elsewhere, extending beneath the intact section of this floor (Fig. 7). Furthermore, when we lifted the mosaic floor of Room 3, we again found a soil layer of the same characteristics, composition and thickness as those found in Rooms 4 and 2 (Figs. 8-9). So, we can conclude that the soil layers found in Rooms 4, 3 and 2 between the *nucleus* and bedding layers are an original part of the foundation layers of these mosaic

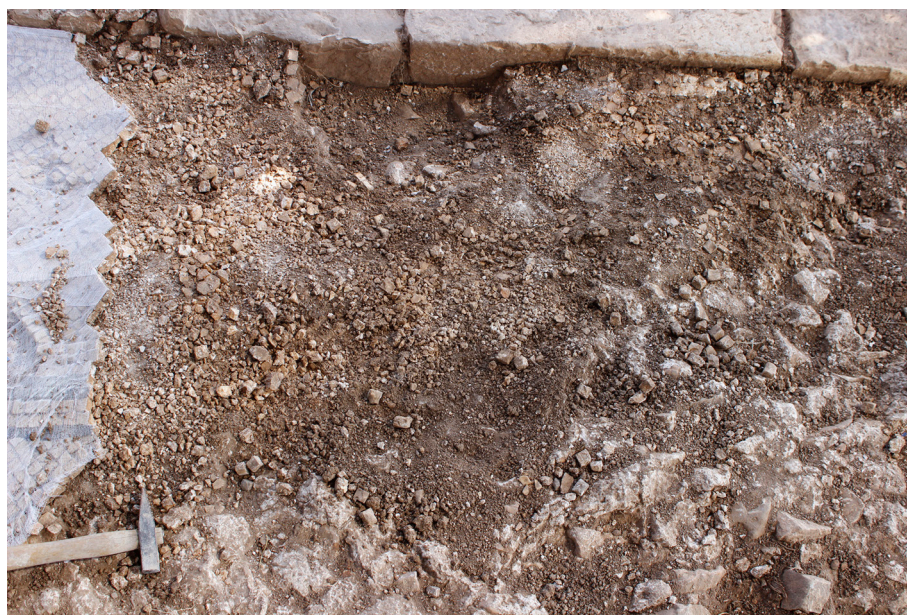
FIG. 8. Remains of the bedding and soil layer after lifting a mosaic section in Room 3.

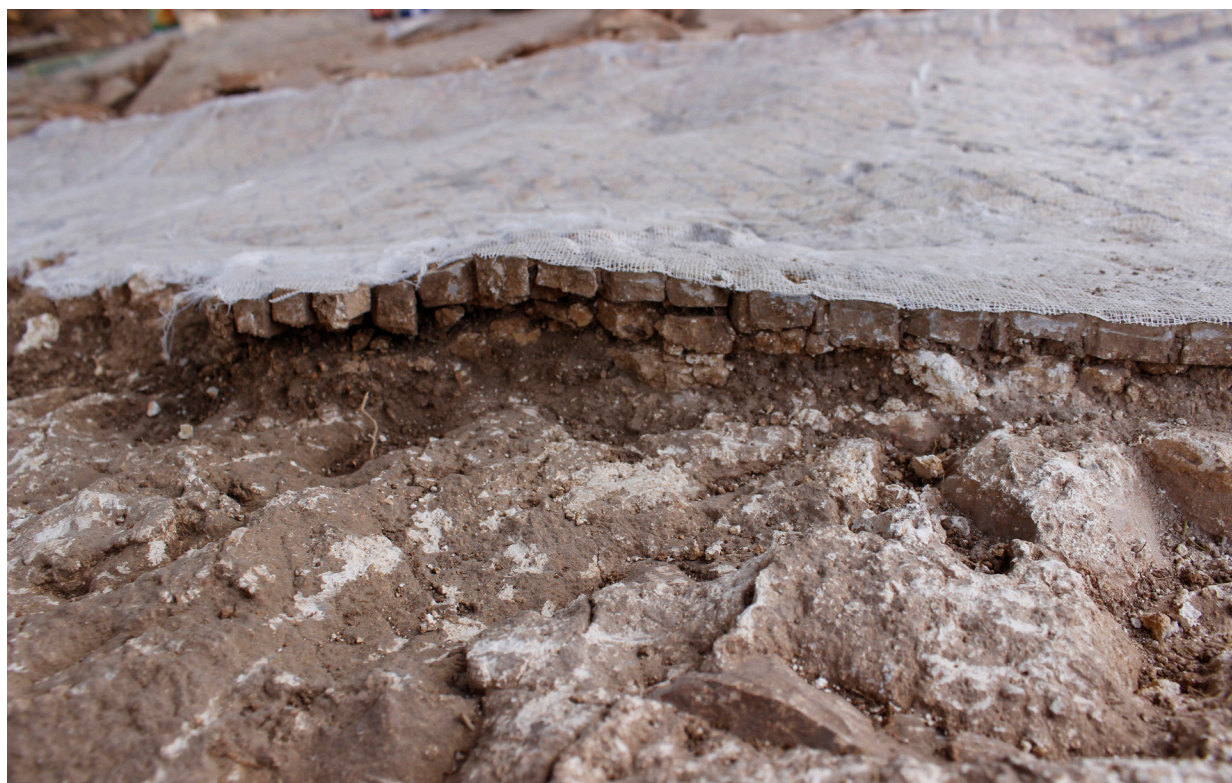
FIG. 9. *The soil layer in between the bedding layer and nucleus in Room 3.*

pavements. The thickness of this 'extra' layer ranges between 1 cm and 3 cm, depending on the regularity of the surface of the underlying *nucleus* layer (Fig. 9). For further details on its composition, please see the following section.

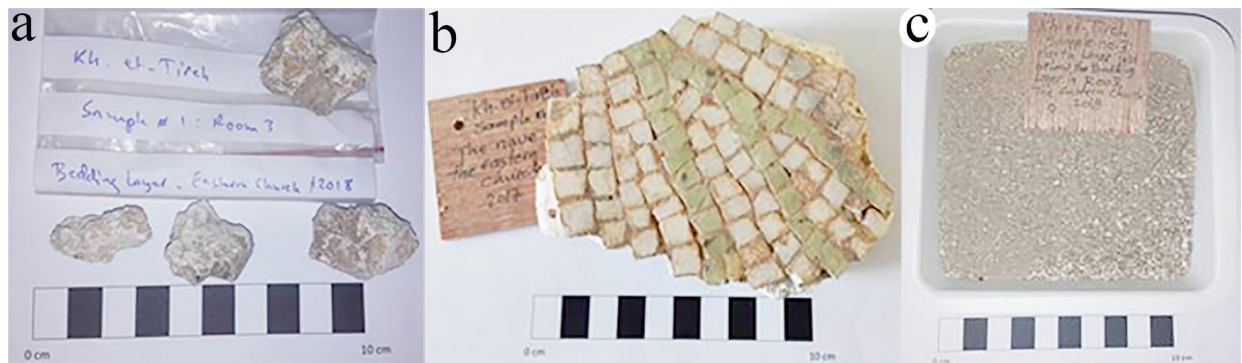
FIG. 10. Samples studied: (a) Sample # 1 consisting of several fragments of the mosaic from Room # 3 of the Eastern Church taken in 2018; (b) sample # 2 consisting of a mosaic fragment taken from the nave of the Easter Church in 2017; (c) sample #3, taken from an earth layer found just below the bedding layer in Room # 3 of the Eastern Church.

(plaster); the other one comes from an earth layer located just below the bedding plaster in Room # 3. Fig. 10 below shows these three samples, respectively. In sample # 3, fragments include the bedding plaster still attached to a mosaic cube.

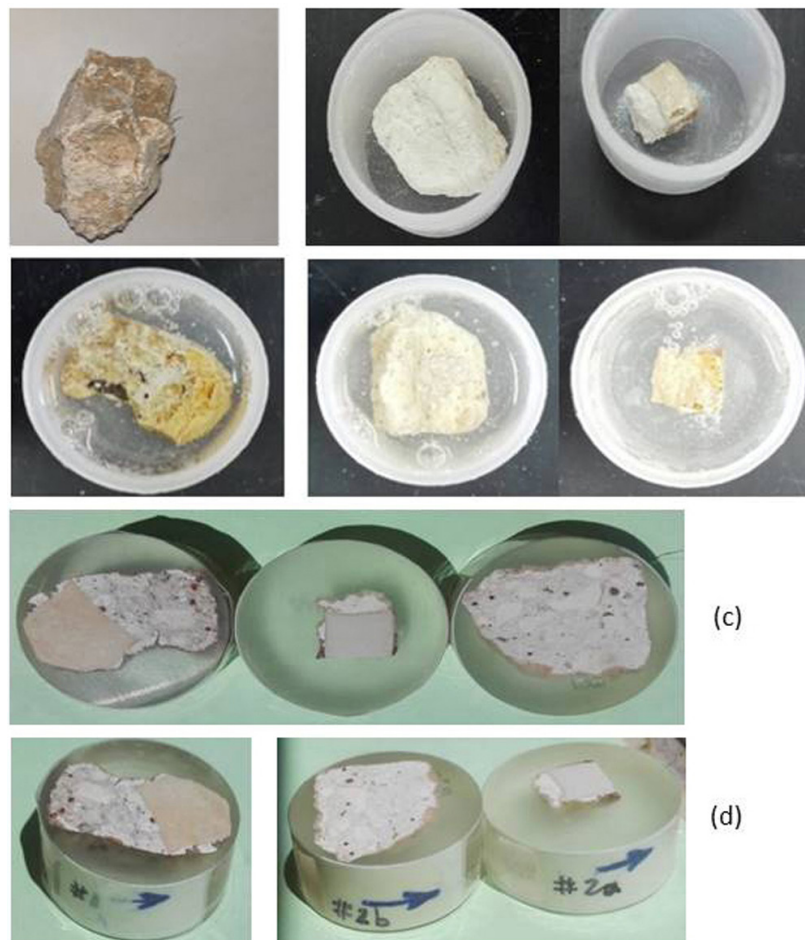
FIG. 11. Samples preparation for microscopic examination: a) Samples 1, 2a and 2b cut and placed in cups; b) epoxy is poured on samples for consolidation and grinding; c) samples ground and polished; (d) orientation of samples with respect to mosaic surface taken, arrows point to upper surface.

polished as needed. Samples were placed in plastic cups (Fig. 11a) and epoxy resin was poured until the cups are filled (Fig. 11b). Dry warm air was blown at distance above the cups to expel air bubbles that form during mixing of the epoxy resin with the hardener before pouring it. Once the polymer is dry the discs were removed from cups; the samples will be showing at the lower sides of the discs. The upper side of each disc was first ground to obtain flat and soft surface. This step is needed to make it easy to hold during grinding of the sample side and to allow the disc to sit flat and horizontal on the microscope stage for observation. Grinding of samples was carried out under a stream of water and using sand paper with decreasing grain size of 320, 400, 600, and 1200. Now surface of polished samples is ready for observation with optical microscope (Fig. 11c). Discs are marked with arrows to indicate the surface of the mosaic (Fig. 11d).

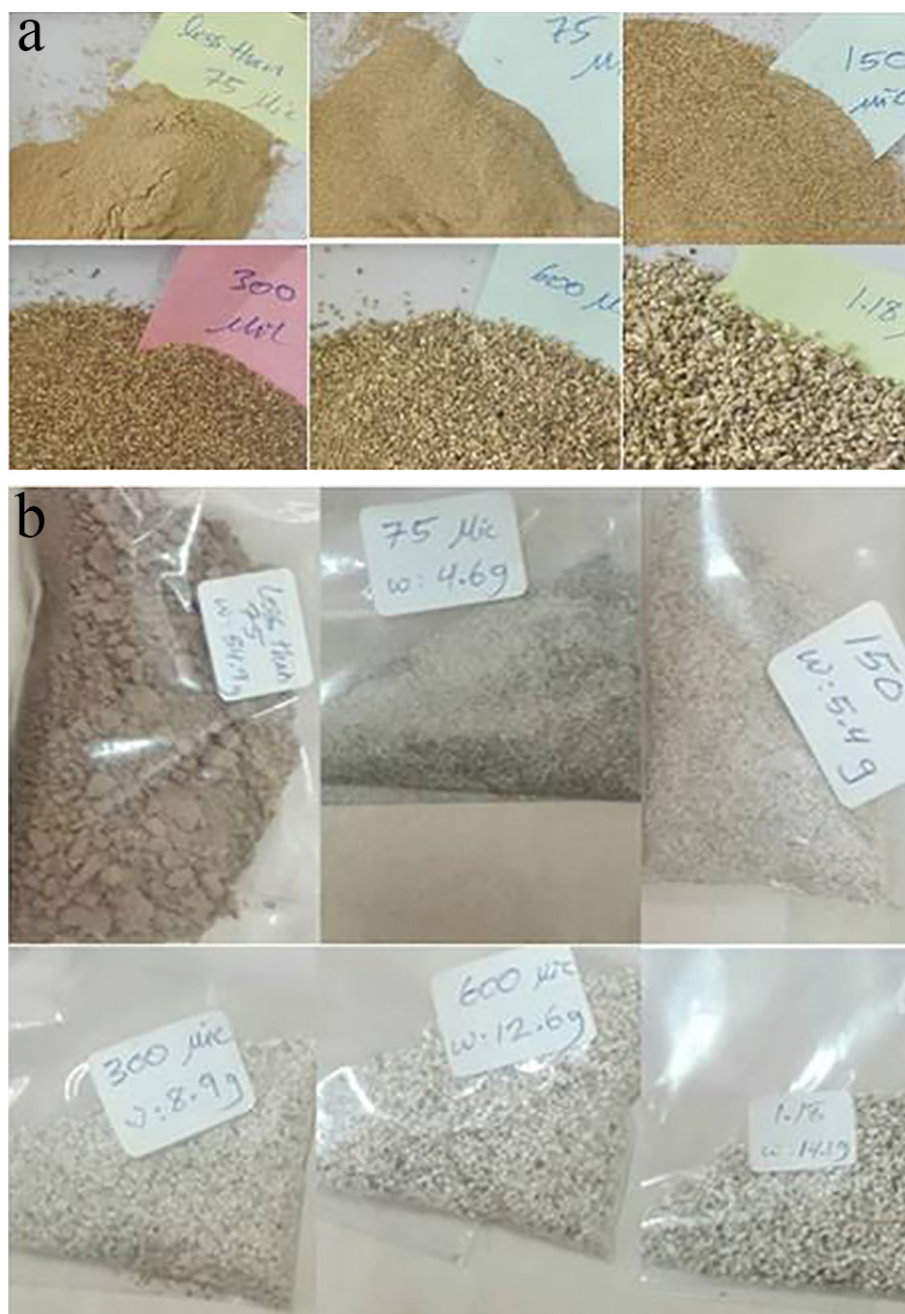
FIG. 13. Particle size distribution of the mosaic fill material: a) after screening of dry sample; b) after screening of wet sample.

Data obtained for the fill soil sample screened dry are presented in Fig. 12. The table also shows data obtained for the same sample screened suspended in water. Collected size fractions in both tests are shown in Fig. 13a and b, respectively. These data are presented by the histograms of Figs. 13a and 13b. Histograms show that granulometric analysis of dry fill soil material is misleading in representing the proportion of the fine materials which is mainly composed of clay (Fig. 14a). The fine fraction –<75 $\mu$ – is underestimated and only makes about 12% of the total mass. Otherwise, the sand fractions are overestimated due to the fact that large amount of clay is still adhering to the sand particles, making grains appear larger than they are and making each size fraction higher. On the other hand, histograms of Fig. 14b provide a realistic measure of the grain size distribution of both the sand and the clay materials. Thus, the clay component amounts now to over 50%, indicating that the two materials –clayey soil and sand– were prepared in a 1:1 ratio. Moreover, the particle size distribution of the sand component is now meaningful. The wt.% of size fractions increases as the particle size increases. There is an artificial cut in particle size at 2000 $\mu$ . It is worth noting that the sieve with 2000 micron opening did not retain any sand material. This indicates the voluntary elimination of any larger particles. One can claim that a sieve of 2000 $\mu$  (= 2 mm) size opening –us mesh 10– was employed to screen the sand material before mixing it with equal proportion of clay material.

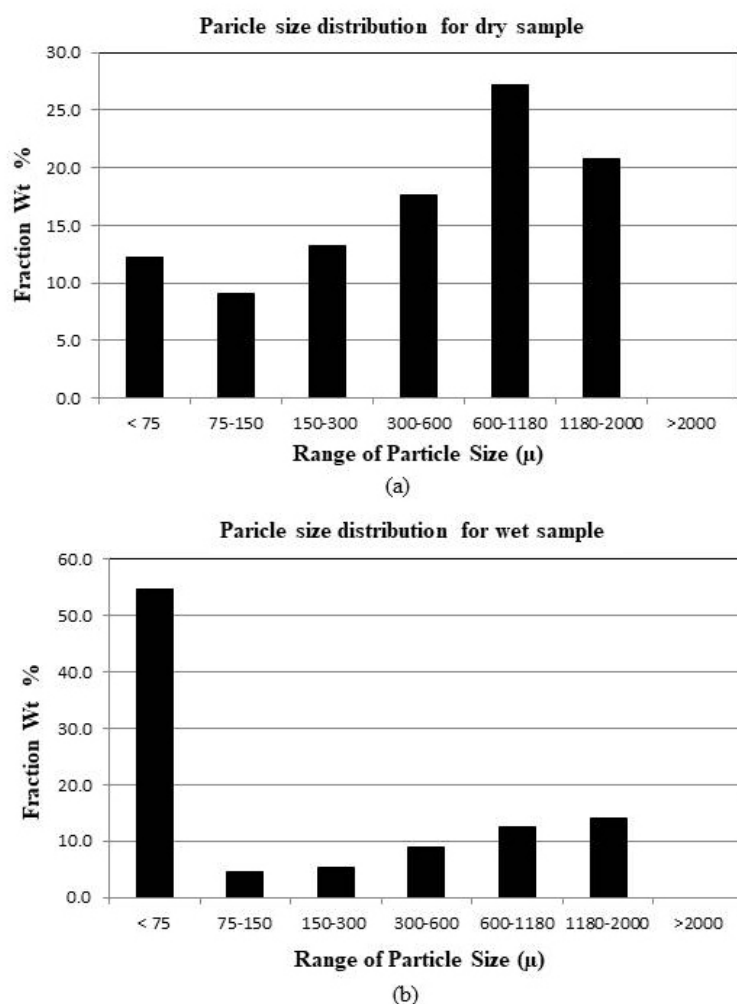
FIG. 14. Different size fraction of the fill soil material after sieving. (a) dry-sieved; (b) sieved as water suspension.

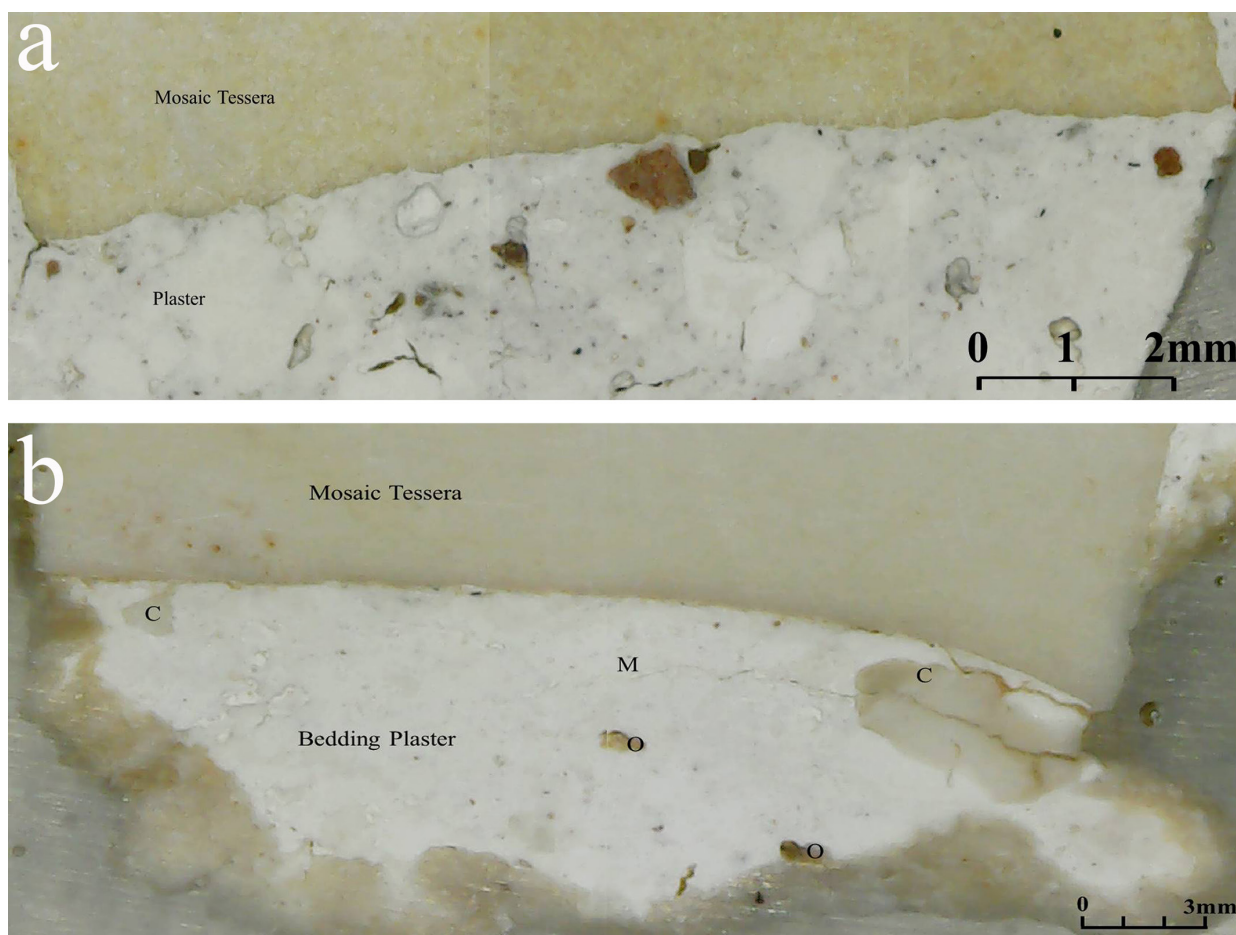
FIG. 16. Photomicrographs of polished sections of Samples 1 and 2b showing both tessera and bedding plaster layer: M = matrix; C = calcite; O = iron oxide-rich grain.

One learns several things from the microscopic examination. The polished samples mentioned above and shown in Figs. 11c and 11d were examined using an optical microscope in reflected light mode. Digital images were collected for each sample at different magnification power and for different zones of the section. Selected micrographs are

presented in Figs. 16-18. In Fig. 17a and b low magnification images show, for samples 1 and 2b, respectively, areas covering parts of the tesserae and the adjacent bedding plaster layer. Both tesserae are made of a homogenous yellowish limestone. The lower sides of the tesserae are not rigorously flat, which could be done in purpose to improve the mechanical strength of the mosaic to avoid the exfoliation of the tesserae from the bedding plaster. The adjacent plaster layer does look different between the two samples. Sample 2b, coming from a finer mosaic, has a fine and homogenous plaster, which conforms with known recipe described by Vitruvius (*De Arch.*, vii, 1). Sample 1, on the

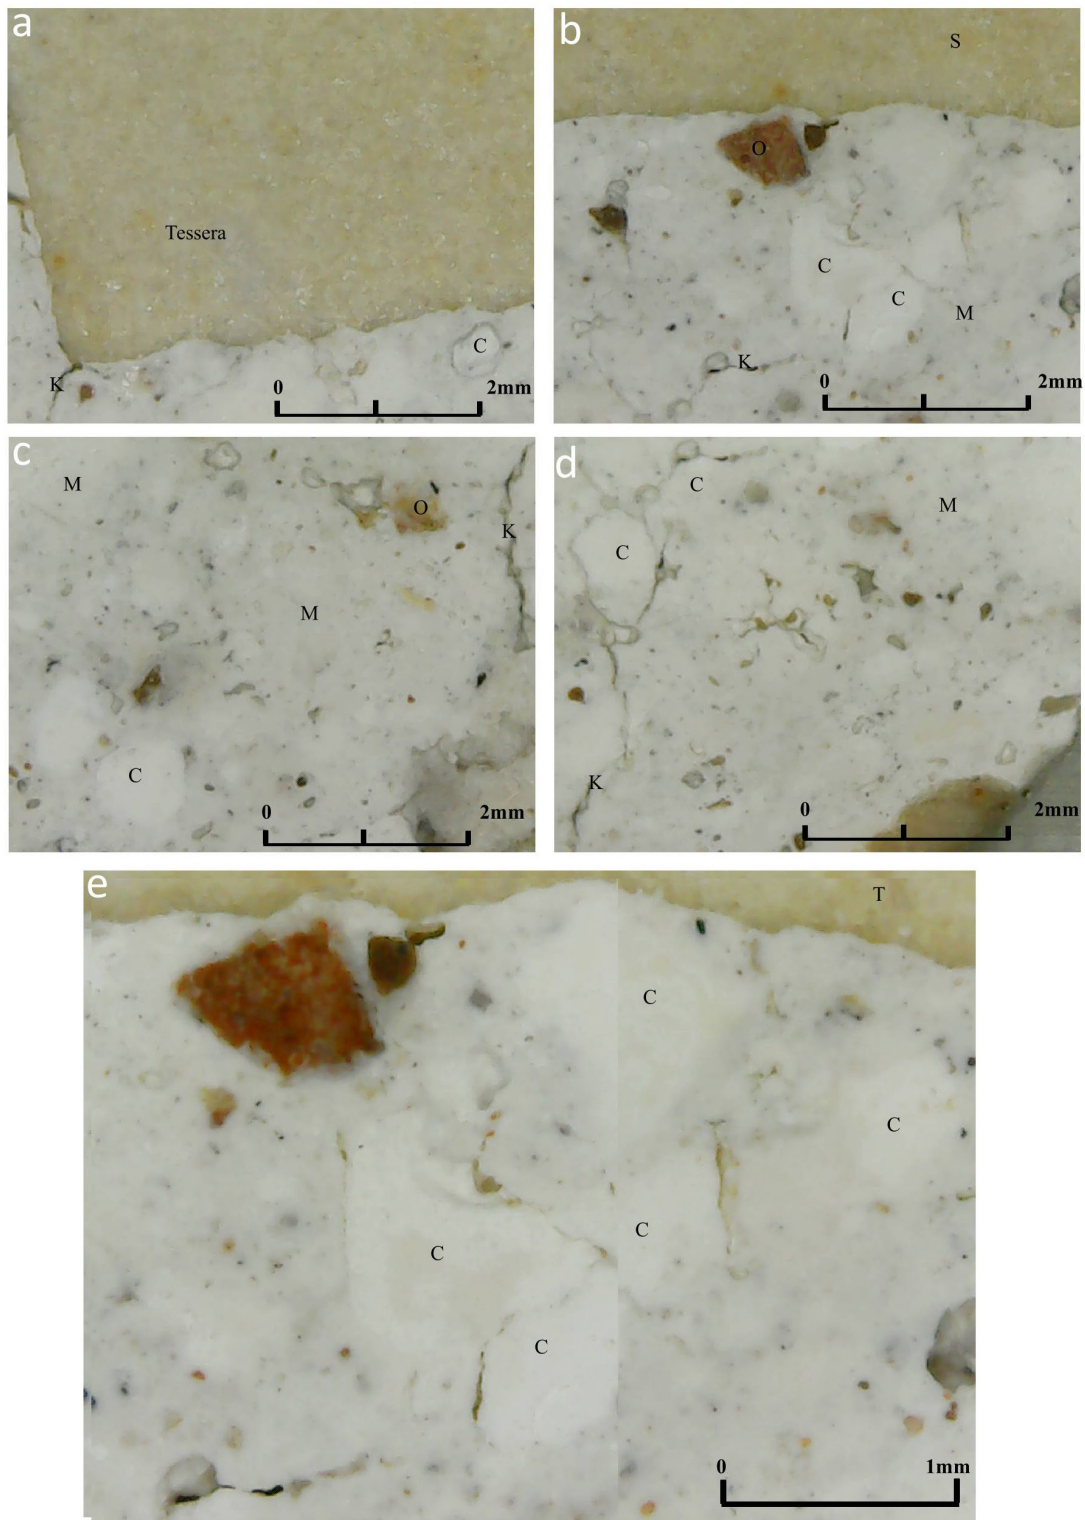
FIG. 17. Photomicrographs of polished section of Sample 1 showing more details of the texture: M = matrix; C = calcite; O = iron oxide-rich grain; K = crack; S = mosaic stone.

contrary, has higher proportion of sand mixed with the slaked lime and larger grain size. Figs. 17 and 18 show more details of the bedding plaster in sample 1: some red particles of iron oxide-rich material, derived most probably from brick powder (Figs. 17a-c), are sporadically present especially in areas close from the edges of the plaster layer. Also are present larger grains of rock –limestone– as well as some large granules of slaked lime (Figs. 17c and d). The fact that Sample 1 has chipped easily leaving a 4-5mm plaster layer attached to the *tessera*, may indicate two successive layers of plaster, also recommended by Vitruvius.

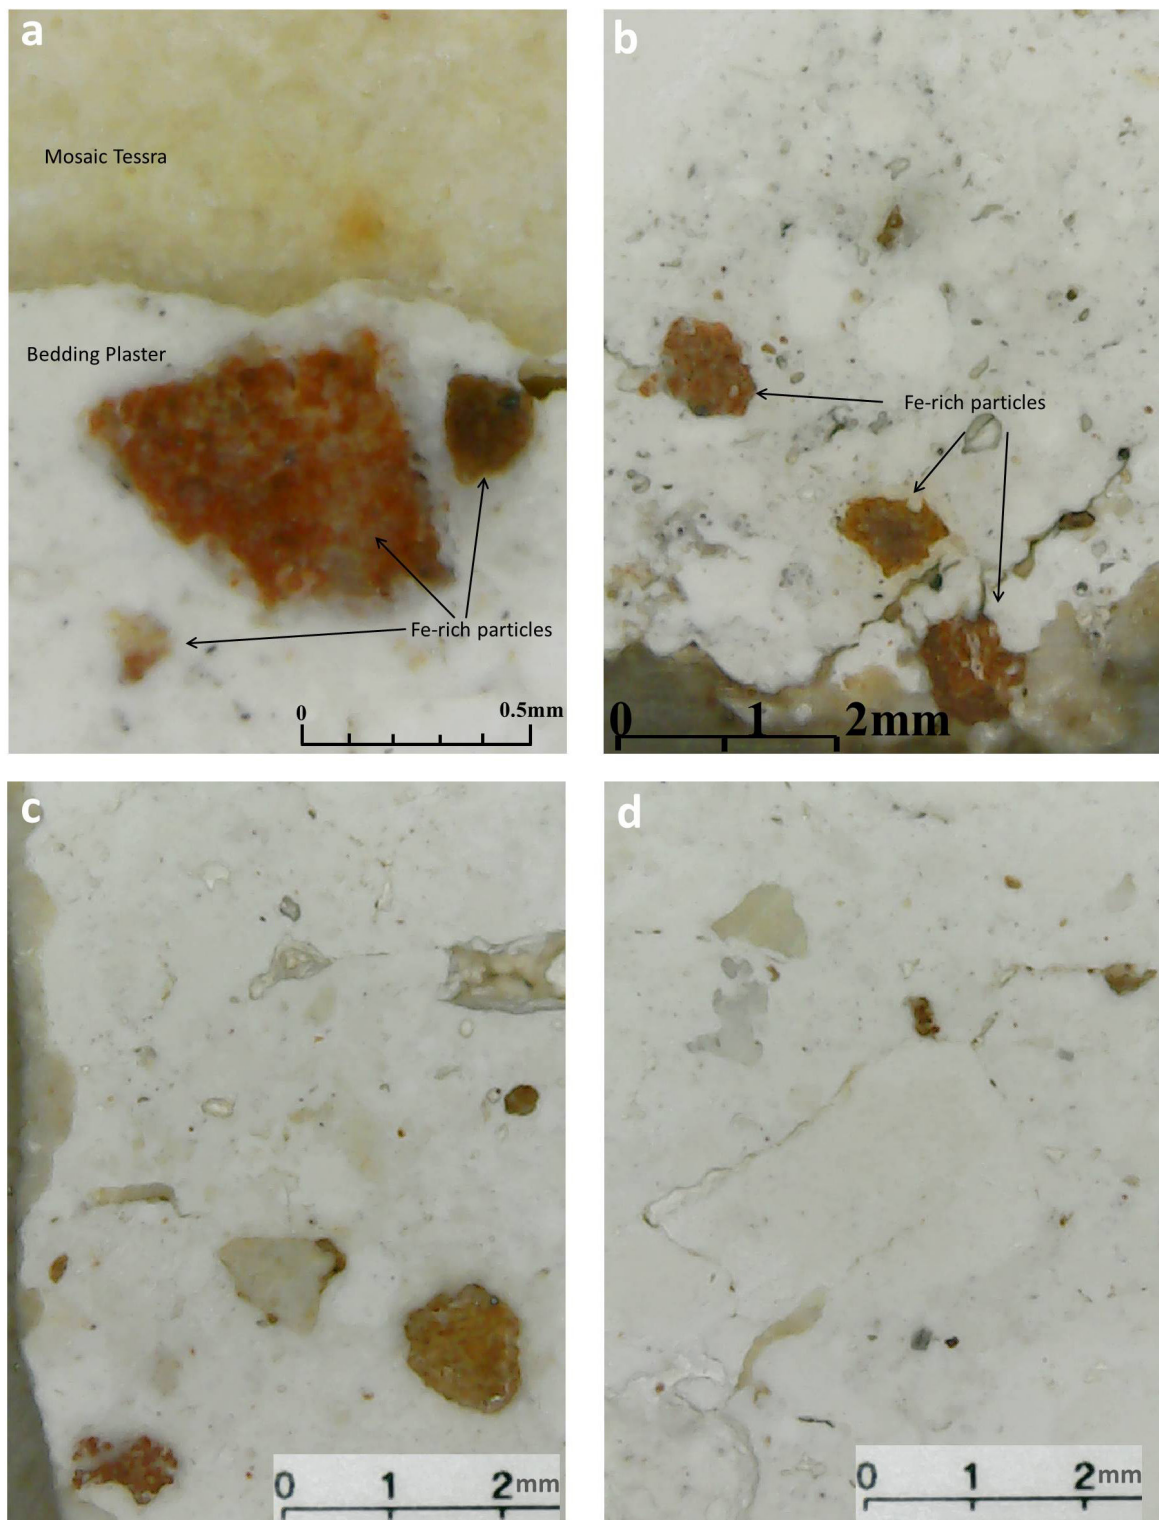
FIG. 18. *Photomicrographs of polished section of Sample 1 taken at higher magnification and showing areas with iron oxide-rich grains.*

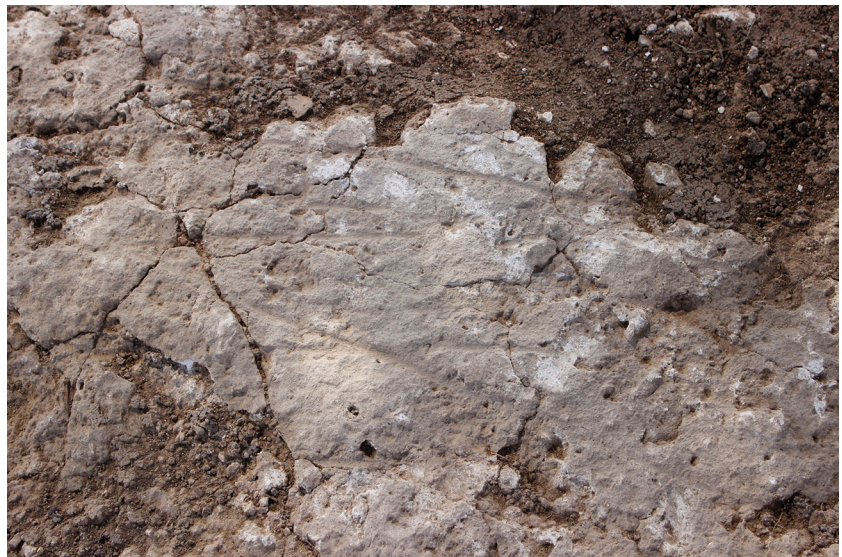
FIG. 20. Plow marks and deep cracks on the surface of the *nucleus* layer in Room 4.

The mosaics and substrates of the southern rooms, as we found them, varied in physical con-dition, ranging from good, through severe dam-age, to complete destruction. Based on the scant overlying earthen deposits—only 0.2 m to 0.4 m thick—which we excavated from the surface of the southern rooms of the Eastern Church at Khirbet et-Tireh in 2015, and also the plow marks clearly visible in the *nucleus* layer of Room 4 (Fig. 20), we

believe that the mosaics in this area of the church were dramatically damaged through agricultural activity, probably over a long period of time. The mosaics of these rooms are distinguished not only
